**DEPARTMENT OF TRANSPORTATION**

Contract #: 04-0120F4Cty: SF/ALA Rte: 80 PM: 13.2/13.9File #: 99.28**WELDING INSPECTION REPORT****Resident Engineer:**Pursell, Gary**Address:** 333 Burma Road**City:** Oakland, CA 94607**Report No:** WIR-013389**Date Inspected:** 25-Mar-2010**Project Name:** SAS Superstructure**OSM Arrival Time:** 700**Prime Contractor:** American Bridge/Fluor Enterprises, a JV**OSM Departure Time:** 1900**Contractor:** Zhenhua Port Machinery Company, Ltd (ZPMC) Chanxing Island **Location:** Shanghai, China

## WELDING INSPECTION REPORT

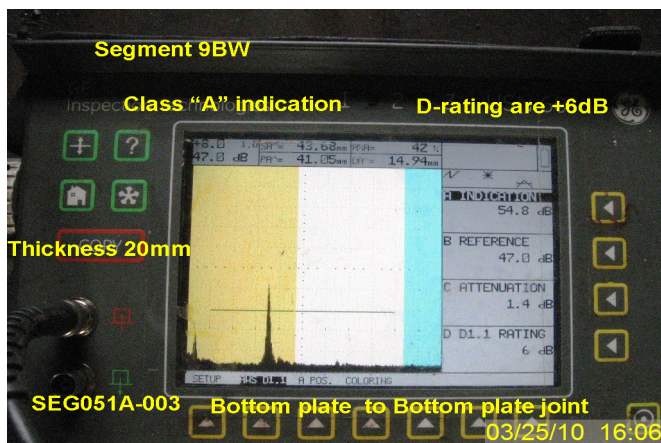
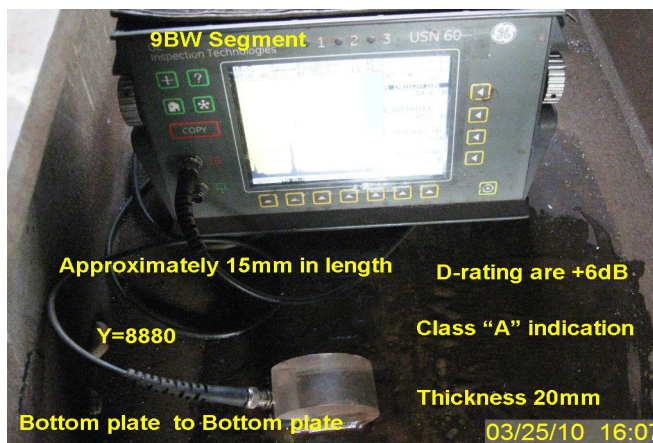
Description of Incident: During the Quality Assurance Ultrasonic Testing (UT) review of weld located on Segment 9BW, this Quality Assurance Inspector (QA) discovered two (2) Class “A” indication measuring approximately 15mm in length. The indications D-rating are +6dB each and the weld joint is identified as SEG051A-003. The weld is a Complete Joint Penetration (CJP) butt weld joining Bottom plate BP95A is identified as PL739A to Bottom plate BP44A is identified as PL715A. The Thickness of the Bottom plate is 20mm. The “Y” locations are approximately 2360 and 8880 mm from one edge of the bottom plate PP76 East Side. The indications are clearly marked by QA on/near the weld. This weld joint is designated as Seismic performance critical weld member (SPCM). The indication is located inside the area that has been previously tested and accepted by ZPMC Quality Control (QC) personnel. As per the contract documents, ZPMC’s QC personnel are required to perform 100% UT inspection of this weld.
